# Опасные экзогеодинамические процессы Қауіпті экзогеодинамикалық процестер *Dangerous exogeodynamic processes*

G. H. Gurbanov

## CHARACTERISTICS OF EXODYNAMIC PROCESSES IN THE NAKHCHIVAN RIVER BASIN

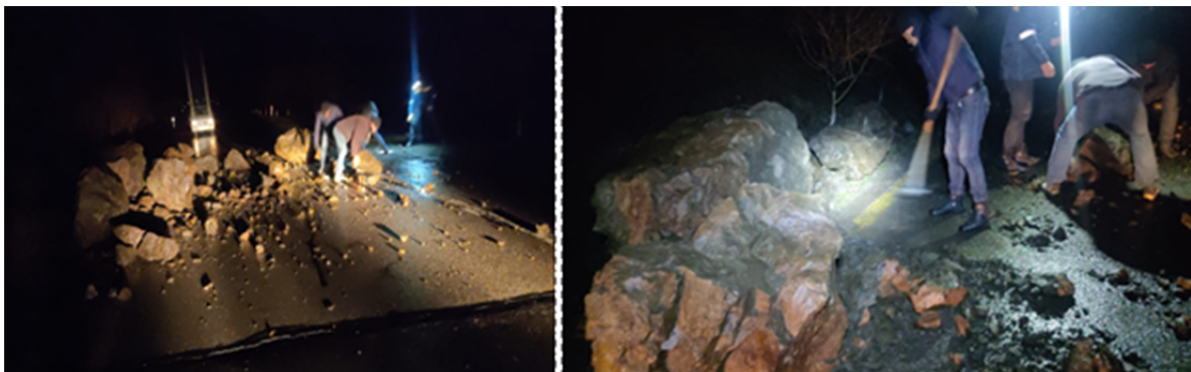
The factors that cause avalanches in the area are different from low mountains to high mountains. Thus, while in some places, frost weathering plays an important role in the formation of avalanches, in other places, sharp changes in temperature, physical and chemical composition of rocks in another area, vegetation, color affecting the heat capacity of rocks, lithological bedding, exposure and degree of inclination of the slopes, etc. plays a role. In a number of cases, excessive rainfall in the area can be considered as an additional factor in the occurrence of avalanches. Thus, on March 18-19, 2024, as a result of the intense rains that fell on the village of Bichenak, large pieces of rock fell near the bridge of Zarnatun and caused traffic restrictions on the highway (figure 2).

Figure 2 – Bichenak village of Shahbuz region (19.03.2024)

The occurrence of landslides in the main valley of the Nakhchivan river creates bigger problems. Thus, as a result of the impact of the landslide that occurred on the right and left slopes of the river, in the territory of Bichenak village, several private houses were seriously damaged. The fact that the landslide extends its range up and down the slope further increases the danger in the settlement. Similar landslides are observed near the village of Kolani along the left bank of the Nakhchivan river to the village of Agbulag. This type of landslide causes the formation of furrows on the slopes, which turn into ravines. In such areas, the erosion processes intensify, the parent rocks come to the surface and are subjected to intense physical wear.

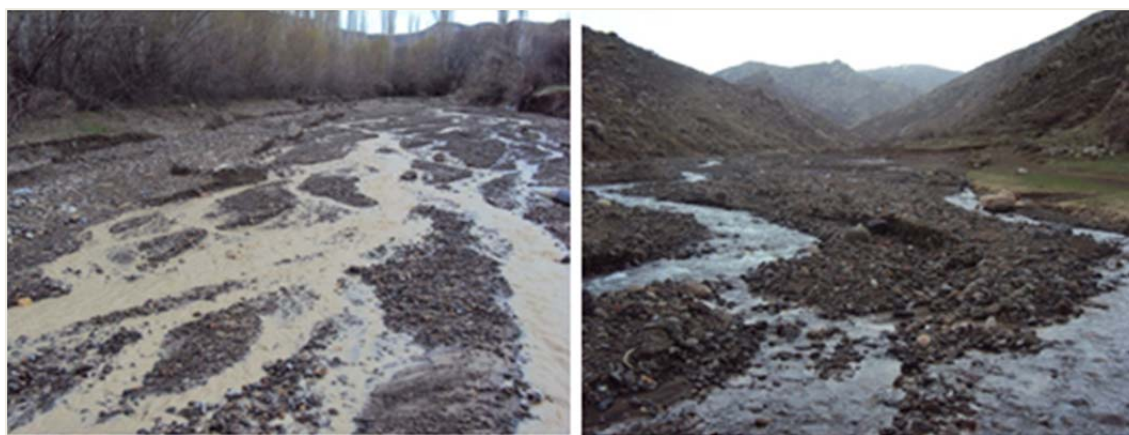
Nakhchivan river (Kolani village district)

Because screes are formed from rock fragments of different sizes, they are partially balanced and break up less often than avalanches. They spread in the form of a cone in ravines and valleys, creating dangerous flood areas, and from time to time flood events with great destructive force develop. The development of such floodplains is observed more often in the areas of Aguchuk, Gotursu, Zarnatun, Khinzirak, Salvartı, Gonaggormez and near the village of Kuku. When flood flows occur, these materials are completely removed to the periphery and are clearly visible in the topography of the bringing cone (figure 5).

Figure 5 – Bringing cone in individual river valleys
