## RARE SEISMOGENIC EVENTS IN THE ILE ALATAU

**Abstract.** In the relatively recent geological history of the Ile Alatau region, large earthquakes have triggered significant disturbances to the earth's surface, including massive seismogenic landslides and debris flows. Through a retrospective analysis of these events and the application of modern research methods, the authors were able to estimate the age and scale of these phenomena. The findings underscore the necessity of considering such large-scale disasters in the planning and development of foothill territories. Given that the region is one of the most seismically active areas in Kazakhstan, the potential for giant landslides and mudflows induced by strong earthquakes represents a tangible and ongoing risk. The study also identified critical gaps in previous research, particularly concerning the timing of past events and methods for quantifying their characteristics. Using data from unmanned aerial vehicle (UAV) imagery, advanced software, and morphometric analysis of solid runoff and mudflow deposits, the authors refined the quantitative parameters of catastrophic natural events that occurred hundreds or even thousands of

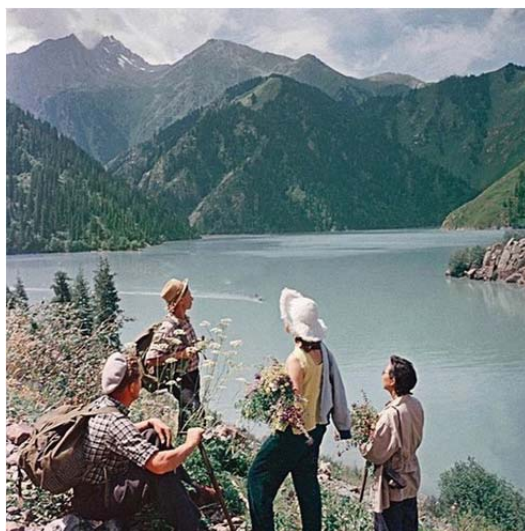
Figure 3 – The Yesik Lake before 1963 (postcard)

**The Yesik.** The exceptional event of July 7, 1963, in the Yesik River valley stands out among the region's natural disasters. At that time, a large mountain lake, which had been formed due to a landslide dam blocking the river at an elevation of approximately 1750 m, burst as a result of the entry of a catastrophic mudflow into the lake. The mudflow had peak discharges of 7,000-12,000 m<sup>3</sup>/s (figure 3).

It is crucial to highlight that this was a highly unusual event: a lake that had existed for thousands of years was completely destroyed by a mudflow – even though the mudflow volume was an order of magnitude smaller than the total sediment volume accumulated in the lake basin throughout its history (figures 3, 4).

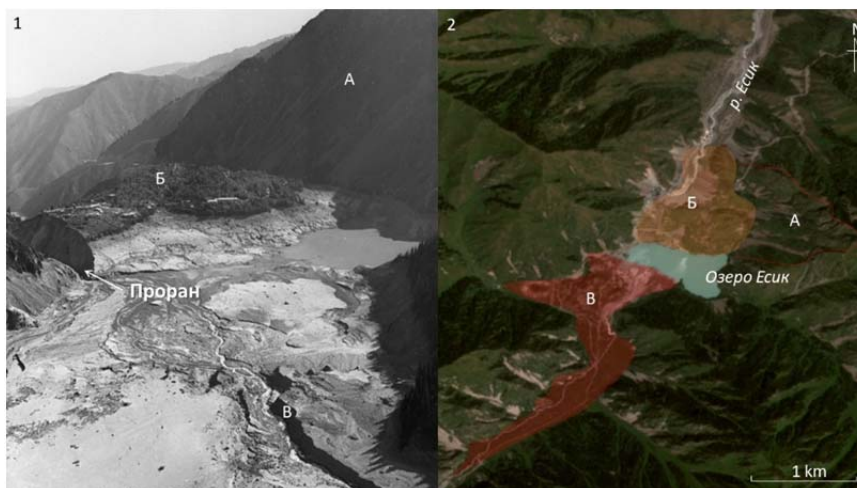
Figure 4 – The blocking landslide and the catastrophic mudflow on July 7, 1963 in the Yesik River valley:

*A* – scarp and landslide detachment zone; *B* – landslide body; *C* – mudflow alluvial fan.

Photo 1 was made by Qazaq TV, Photo 2 is a Sentinel-2 image for July 24, 2021

The glacial mudflow, with a volume of 5.8 million m<sup>3</sup>, caused a sharp rise in the lake level (by at least 1.5 m) and generated destructive waves up to 5.5 m high. This led to an increase in outflow discharge, intense retrogressive erosion in the lower part of the dam, subsequent dam failure, and near-complete drainage of the lake basin [6] (figure 4).

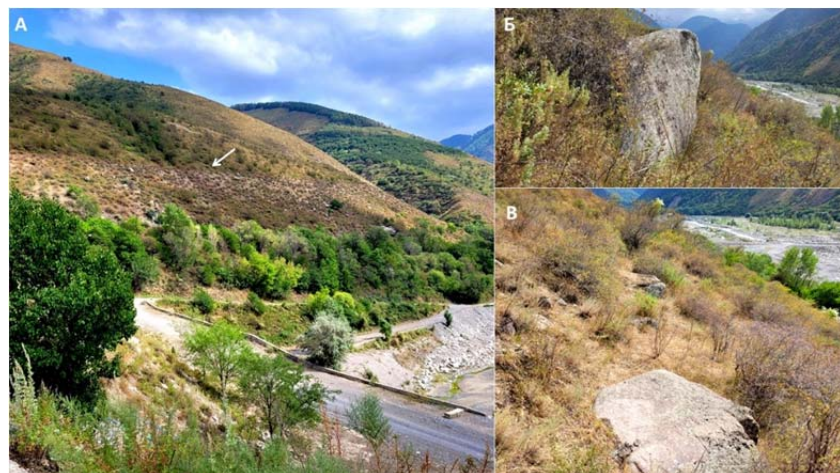
Figure 7 –  
Traces of an ancient giant debris  
flow in the Talgar River valley:  
A – maximum debris flow level  
on the right valley slope;  
B, C – large boulders  
(diameter >5 m) marking  
the maximum level  
of the ancient mudflow

**Talgar.** In the Talgar River valley, at its emergence onto the alluvial fan, traces of an ancient giant mudflow have been identified. These traces remain visible on the right slope of the valley in the form of a distinct boulder line, with some sections located 75 m above the riverbed (figure 7).

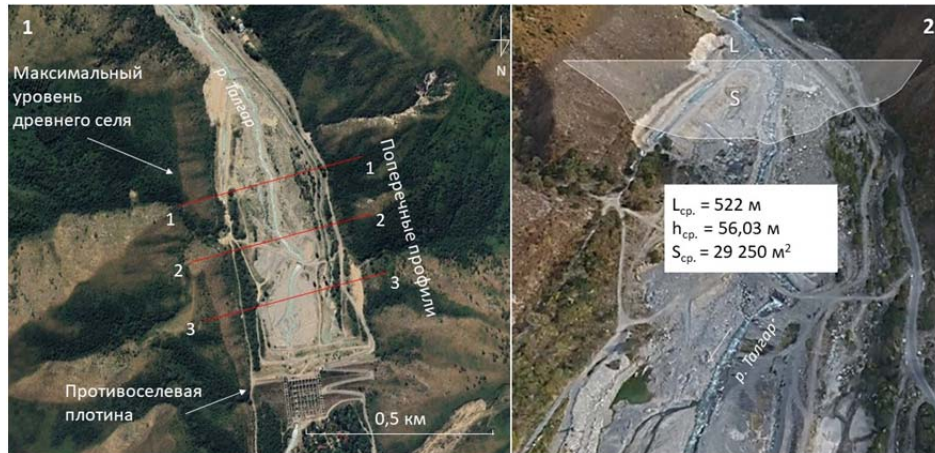
Figure 8 – The section of the Talgar River valley where the giant ancient mudflow exited the valley. The marked features include the maximum flow level on the valley slopes, cross-sectional profiles, averaged cross-section, and an 8.5 million m<sup>3</sup> mudflow protection dam constructed in 2005 [10]

Using modern satellite imagery, it was possible to reconstruct the approximate valley cross-sections at maximum elevations and estimate the approximate cross-sectional area of the ancient mudflow. Based on these rough approximations, the cross-sectional area was determined to be approximately 30,000 m<sup>2</sup>, which, given the previously mentioned flow depth, results in staggering peak discharges exceeding 500,000 m<sup>3</sup>/s or more (figure 8, table).
